Bike Milk® Lubrication Location & Reservoir Effect

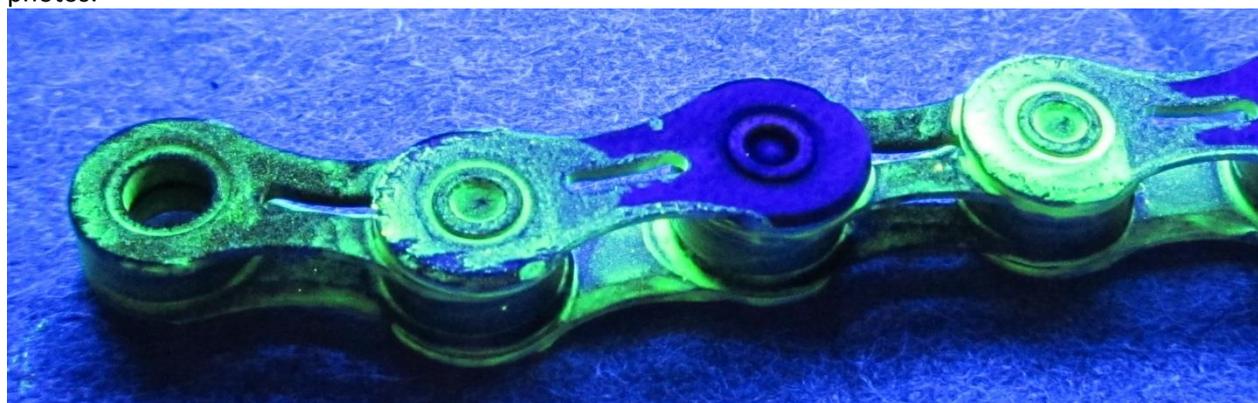
Ride Mechanic dry lubricant **Bike Milk** can easily penetrate and fill the gaps between the rollers, pins, spigots and plates. The carrier solvent then evaporates over time and leaves a thin and tenacious protective film of dry lubricant coating in the 3 areas where it is required. Investigations by **Ride Mechanic** have shown that after thorough chain conditioning each spigot/plate/roller link is coated with 10mg of dry lubricant. To demonstrate the performance in more graphic detail, **Bike Milk** was formulated with a highly fluorescent dye which can be energised under a UV light to become visible. **Bike Milk** was then applied onto a clean, fully degreased and dry Ultegra 10 speed CN6701 chain as per label directions (apply-leave, apply-leave, wipe). With the UV active dye it was very easy to identify where the lubricant film locates and bonds. **Note:** this example was not wiped down and excess unnecessary film residue is evident on surface. The excess was wiped off for other photos.

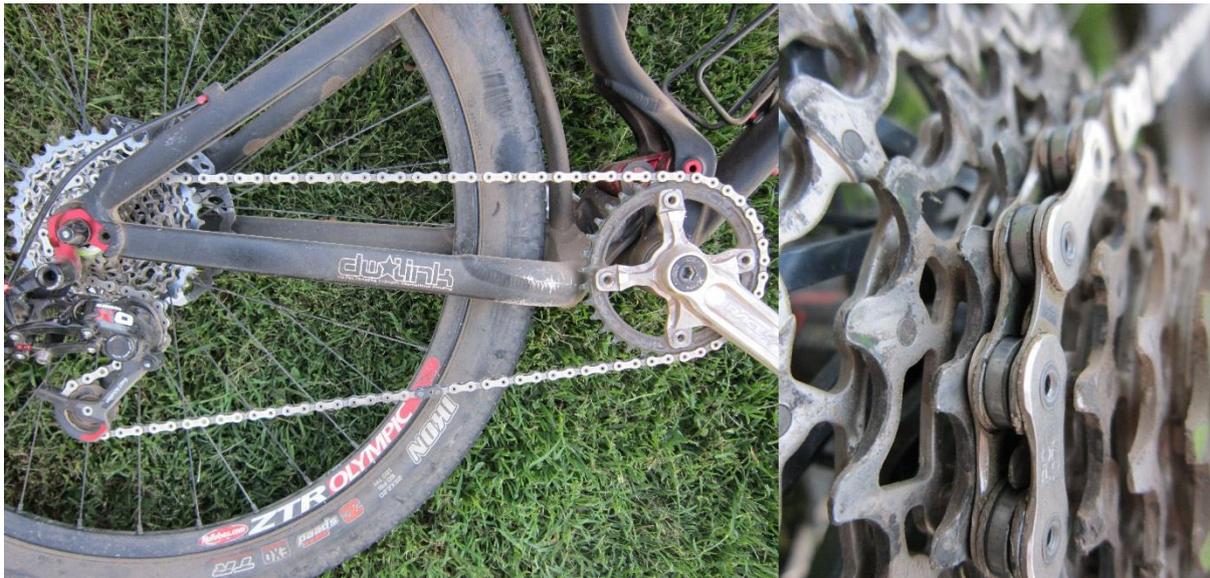
The test bike with fluorescent **Bike Milk** was ridden cross country on fire trail and single track for 2 hours in dry and dusty conditions with ambient temperature of about 25°C. The 1x10 drivetrain ran smooth and quiet for the duration of the ride. Riders will recognise the typical dirt coverage on the bike which reflects common MTB riding conditions.

A close-up of the cassette (above right) shows the characteristic clean and dry state of the drivetrain which **Bike Milk** users are accustomed to. The chain was then removed from the bike **after the ride** and closer examination under UV light showed where the **Bike Milk** film was located.
